City of Medford
ADA ACCESSIBILITY TRANSITION PLAN
revised July 10, 1992

**AMERICANS WITH DISABILITIES ACT
COMPLIANCE REVIEW**

**MEDFORD CITY HALL
MEDFORD SERVICE CENTER**

JULY 8, 1992

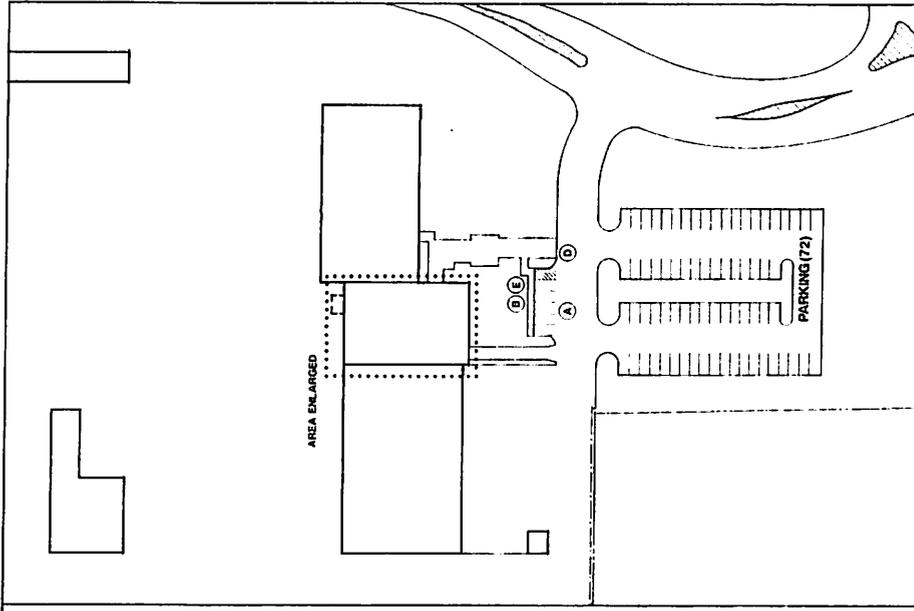
SITE PLAN
NO SCALE
NORTH

- A. NEED ADDITIONAL HANDICAPPED STALL/VAN STALL
 - B. ACCESSIBLE ROUTE
 - C. HANDICAP REQUIRED
 - D. PASSENGER LOADING AREA REQUIRED
 - E. RAMP NEEDS DETECTABLE WARNING
- FOR DRAWING NOTES 1-24 REFER TO PREVIOUS PAGE.

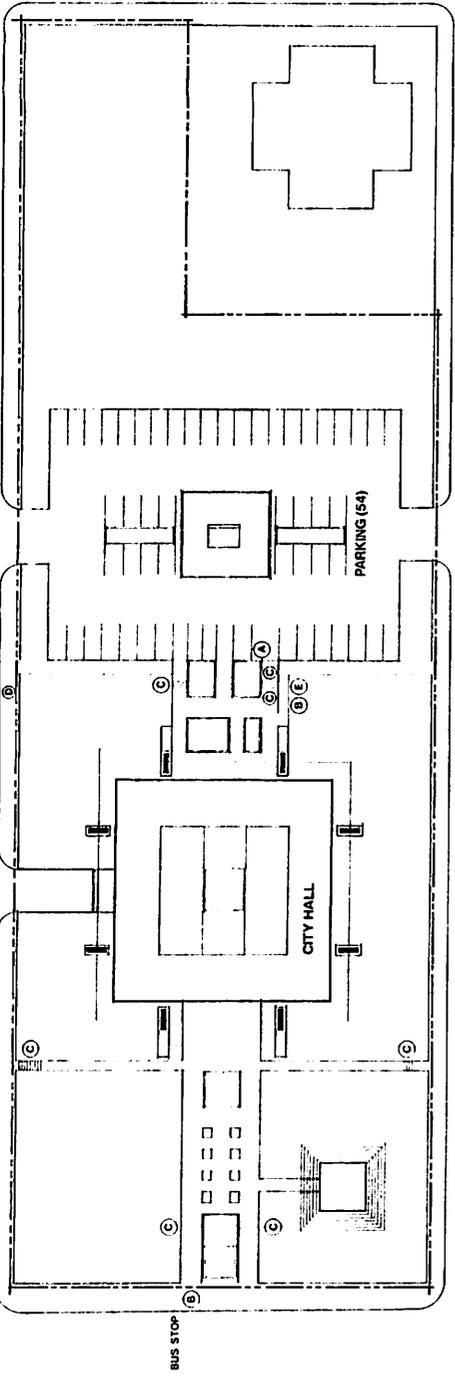
SITE PLAN
1"=30'-0"
0 10 20 30
NORTH

- A. NEED ADDITIONAL HANDICAPPED STALL, VAN STALL
B. ACCESSIBLE ROUTE
C. HALLWAY REQUIRED
D. PASSENGER LOADING AREA REQUIRED
E. RAMP NEEDS DETECTABLE WARNING.
