Playground Assessment Report

Inspection Date: 12/15/2015

Location: Medford, OR

Playground Name: Children's Community Playground

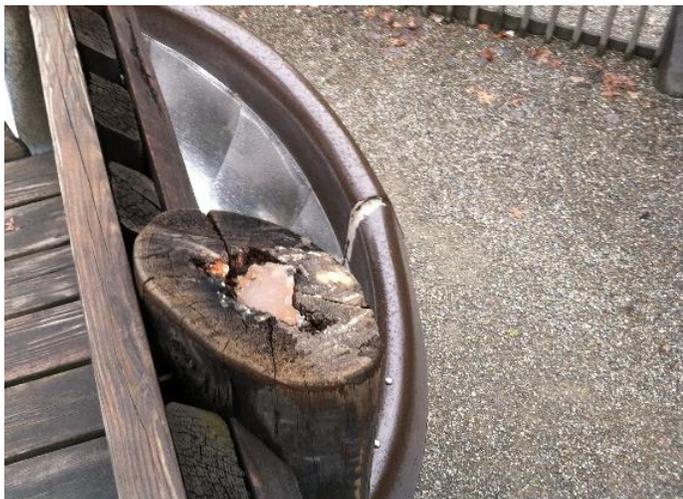
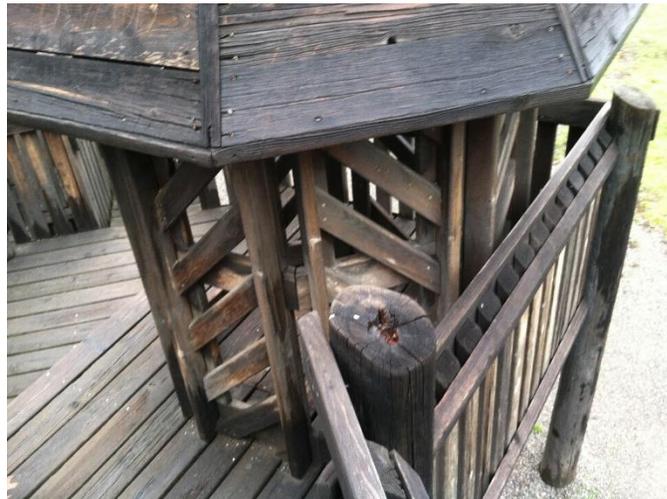
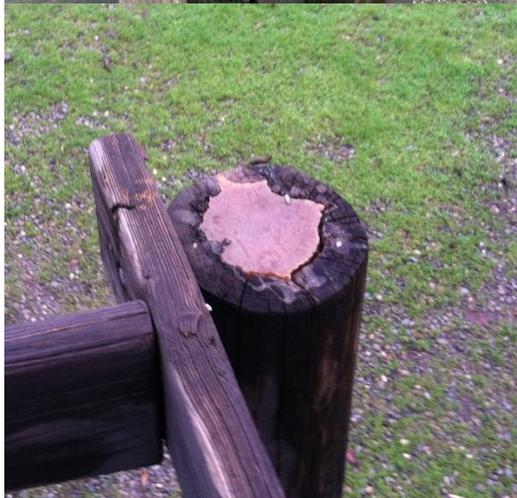
Main support posts

Some poles are beginning to deteriorate.

Repair as needed, contact the office for directions on patching/filling posts

Stain/seal with solid body stain.

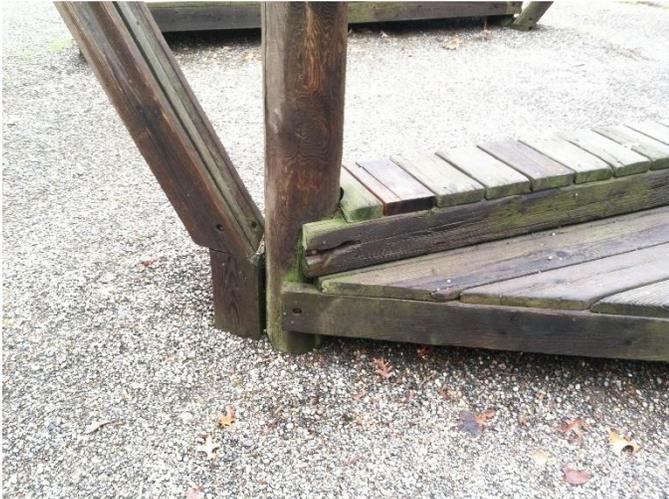
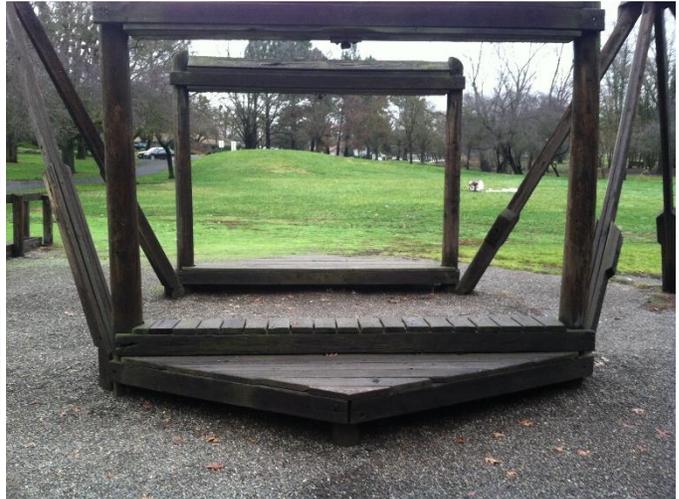
Framing

The framing is in poor condition. Has severe splintering and some structural issues.

Replace where needed

Stain/seal exposed surfaces with solid body stain.

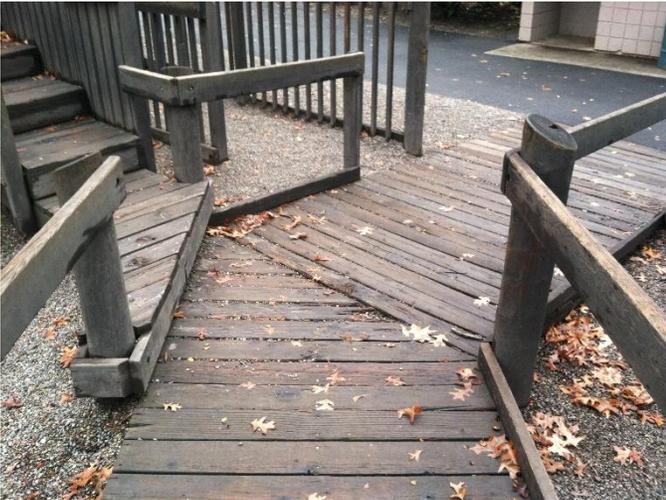
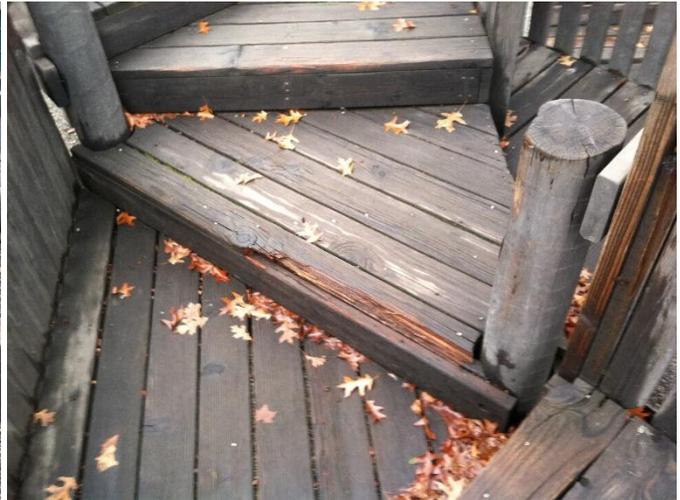
Decking

The decking is in poor condition and has severe splintering

Replace with recycled plastic

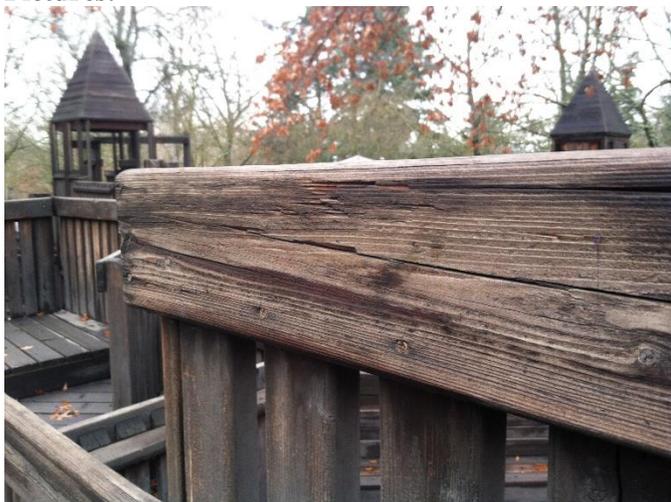
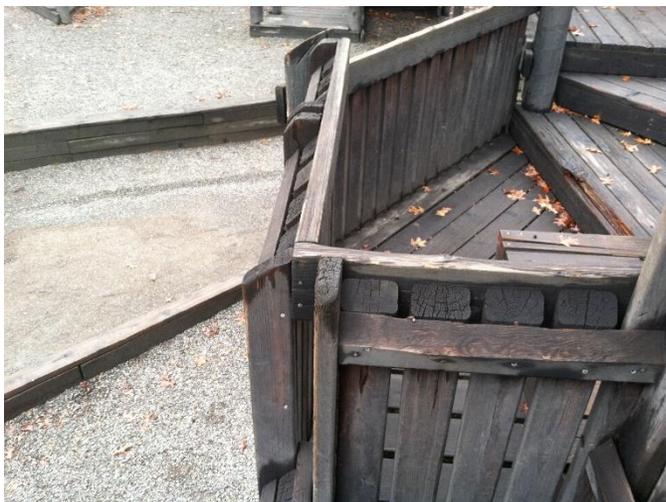
Handrails

The handrails are in poor condition and have severe splintering

Replace with recycled plastic

Raise handrails to 38" (from top of decking to top of handrail)

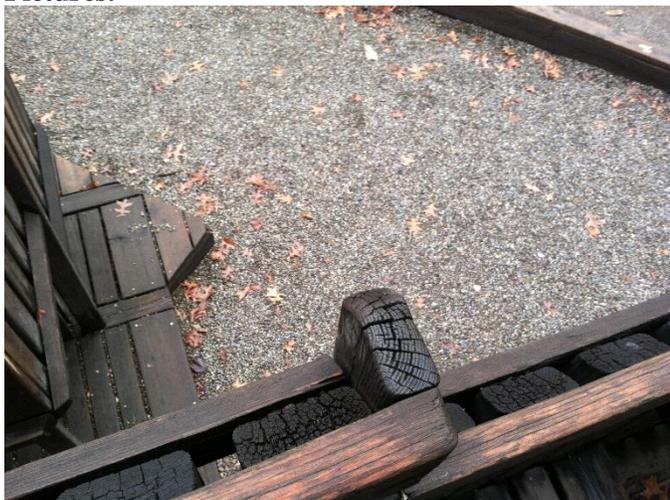
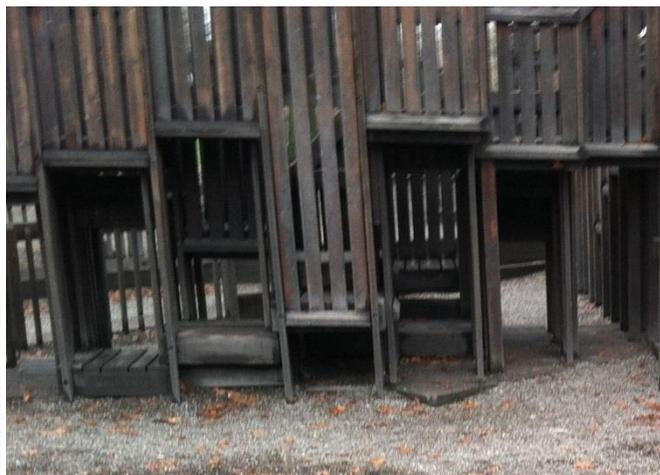
Handrail Posts

The handrail posts are in poor condition. Has major splintering and some structural issues.

Replace with recycled structural plastic.

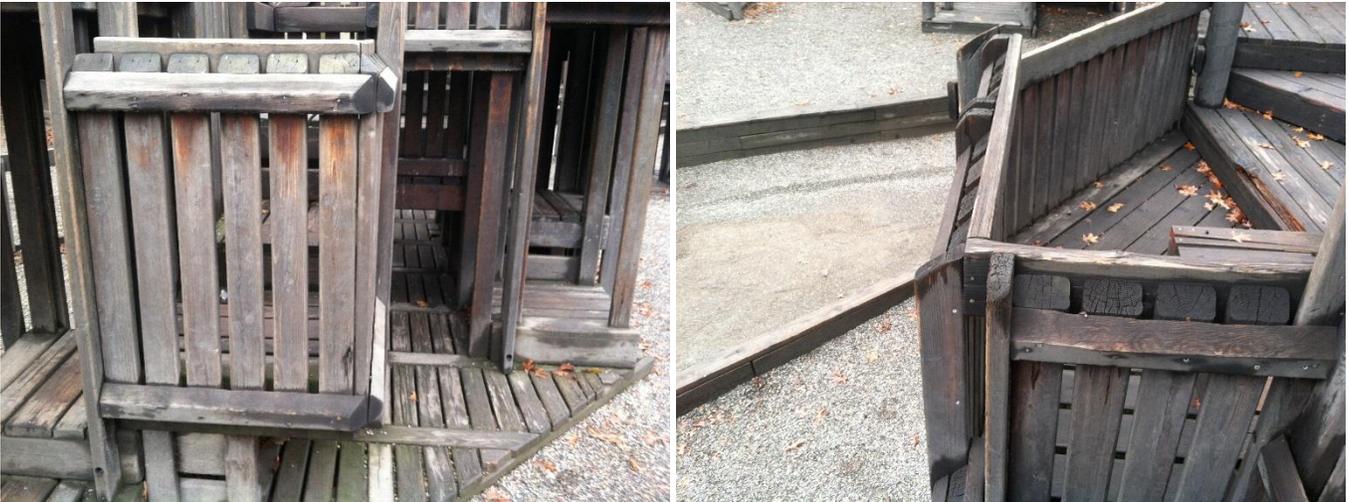
Balusters

The balusters are in medium condition (minor splintering & wear).

Replace with composite balusters.

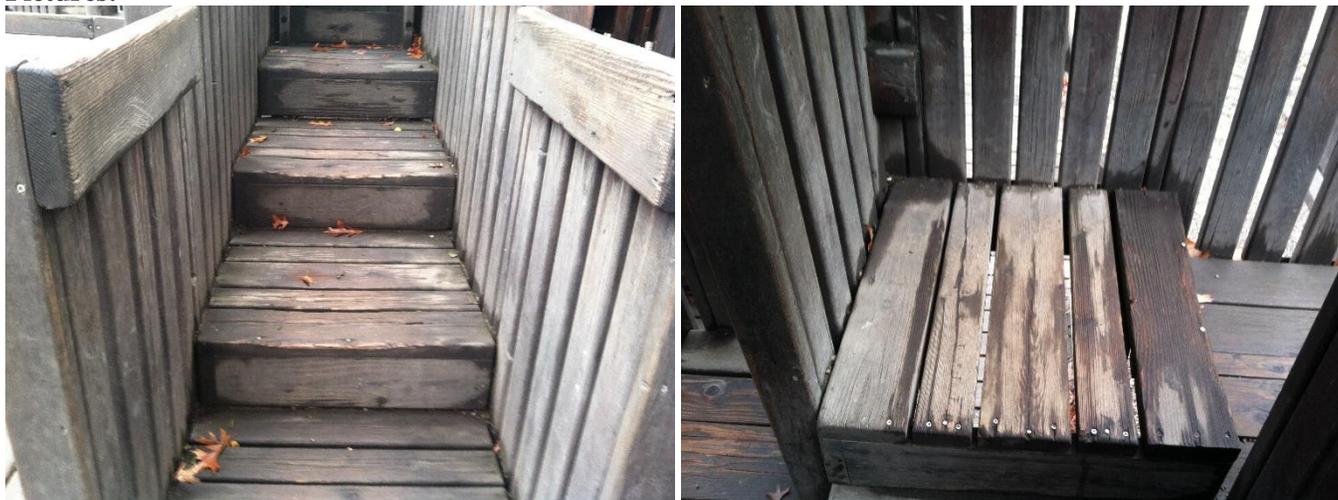
Maze cubes

The maze cubes are in medium condition (minor splintering & wear).

Replace the decking with composite.

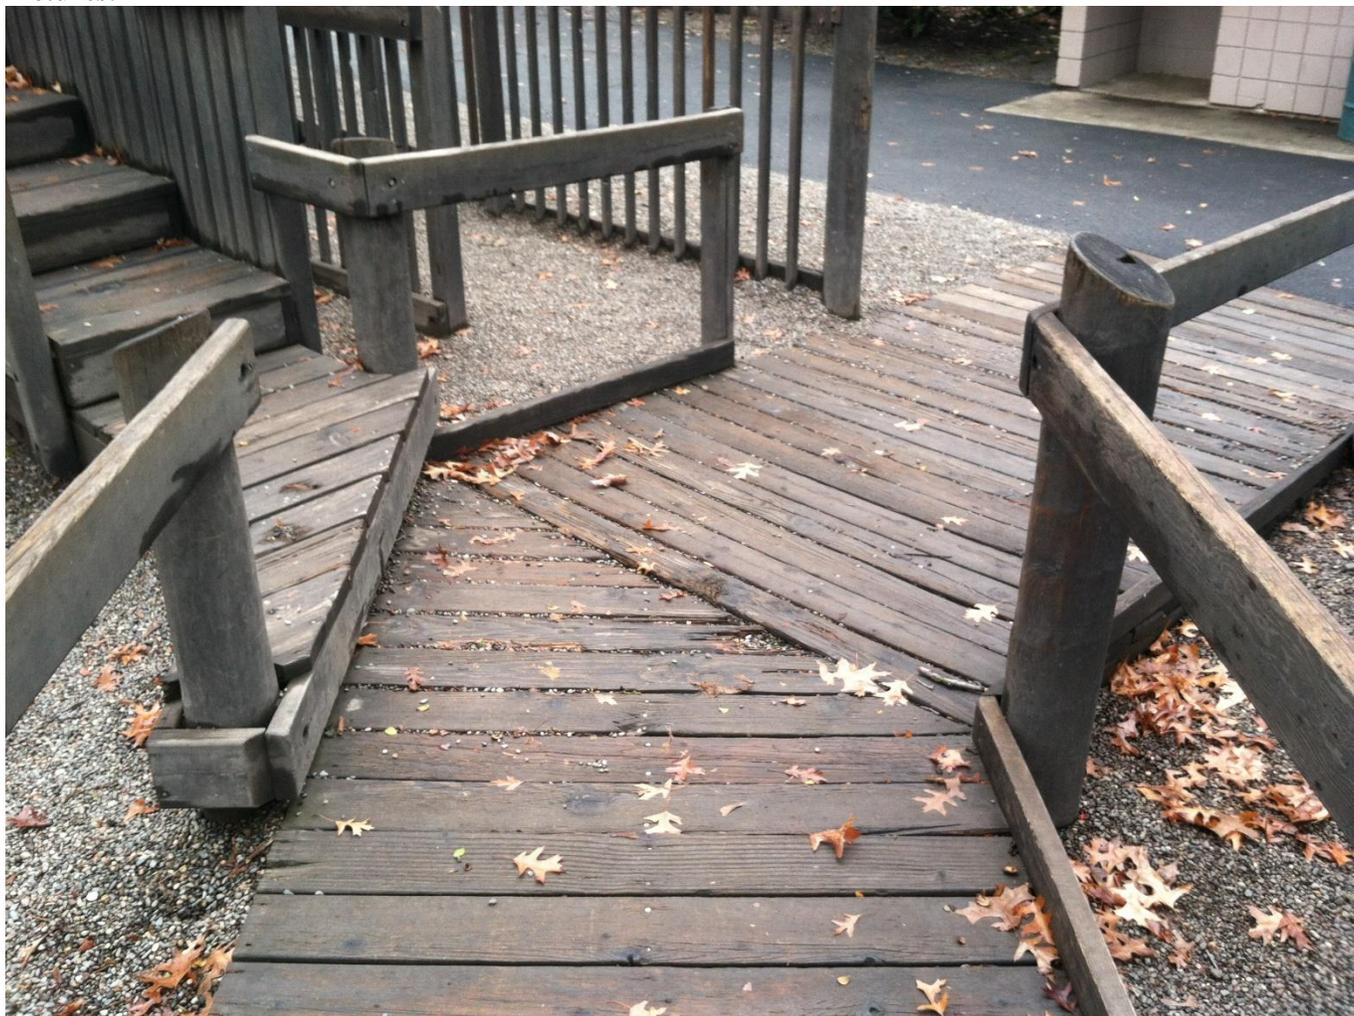
Accessible ramps

The decking is worn and the handrails are not up to current standards.

Replace both with accessible ramp rails.

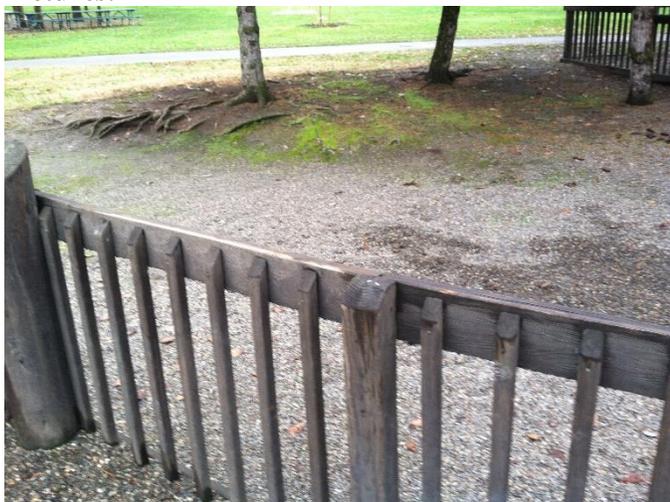
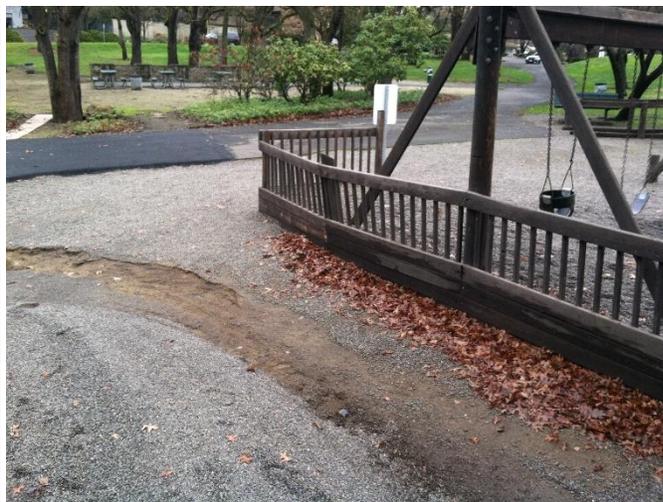
Fence

The fence is in medium condition (minor splintering, missing pickets and wear).

The picket spacing is greater than the current standard, 3.5". The pickets should be re-spaced.

Re-space pickets

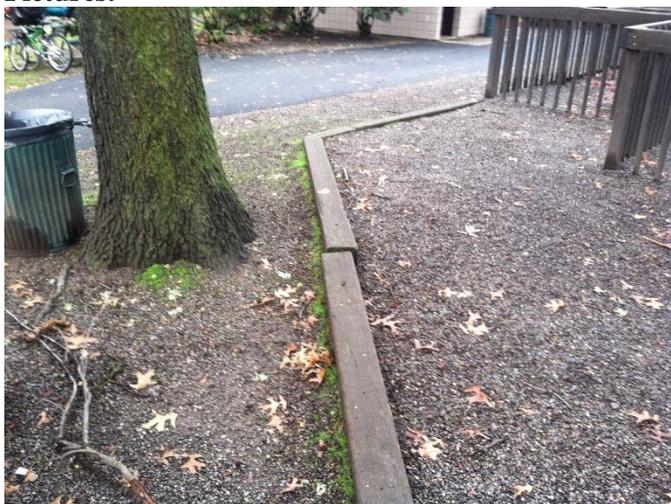
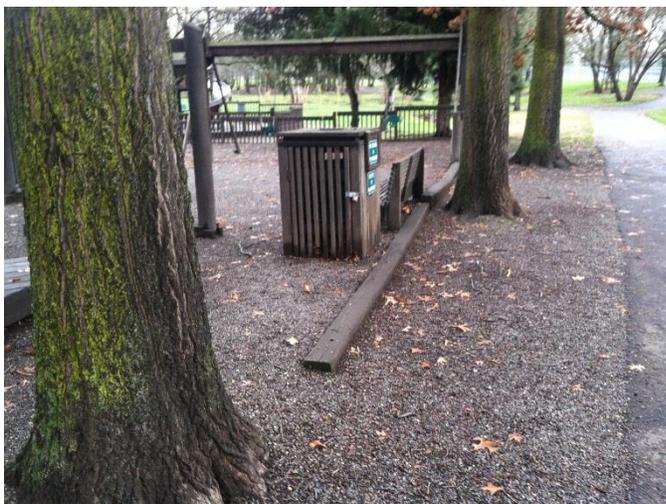
Low perimeter

Perimeter is in medium condition.

Leave as is.

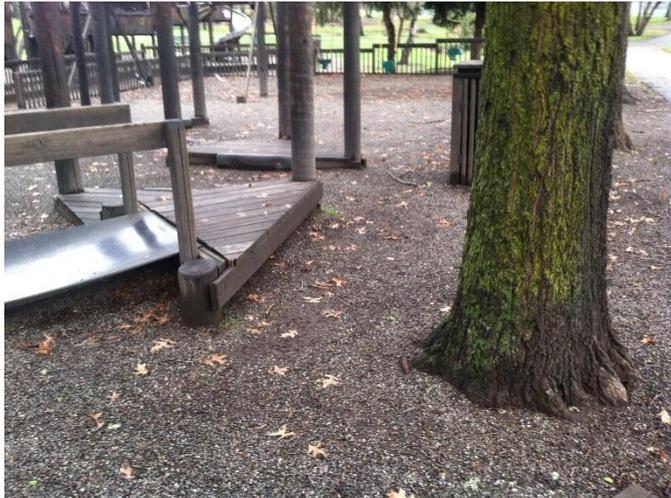
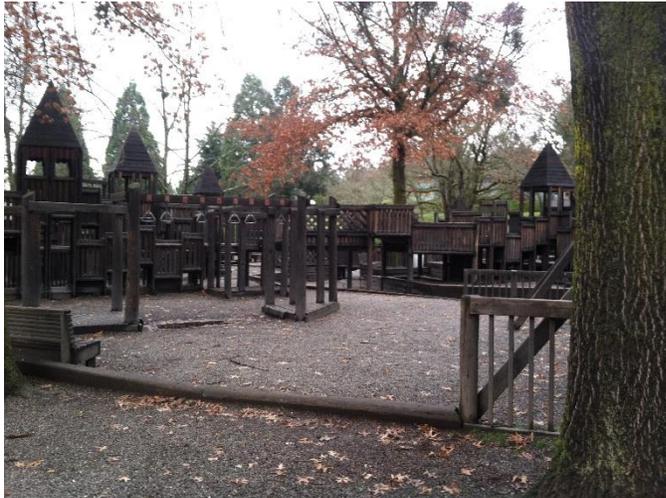
Safety Surfacing

Safety surfacing is in poor condition. Many areas are not at sufficient depth.

Remove pea-gravel and add 12” of engineered wood fiber to 12” compacted depth throughout

Make sure the finished safety surfacing meets all safety requirements.

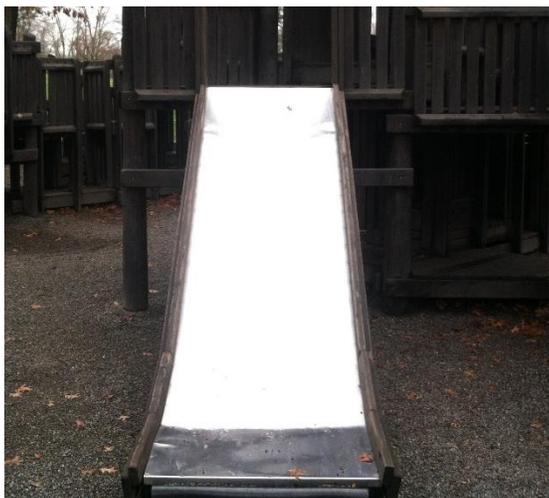
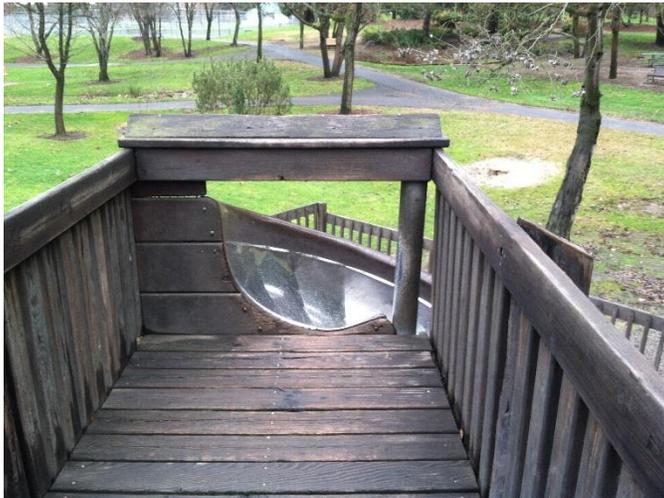
Equipment type/name: Slides – Tube Slide, Circular Slide, Tot Slide

The slides have several entanglement hazards, are metal, and in general, are past a safe life cycle.

Replace all slides with low maintenance manufactured slides

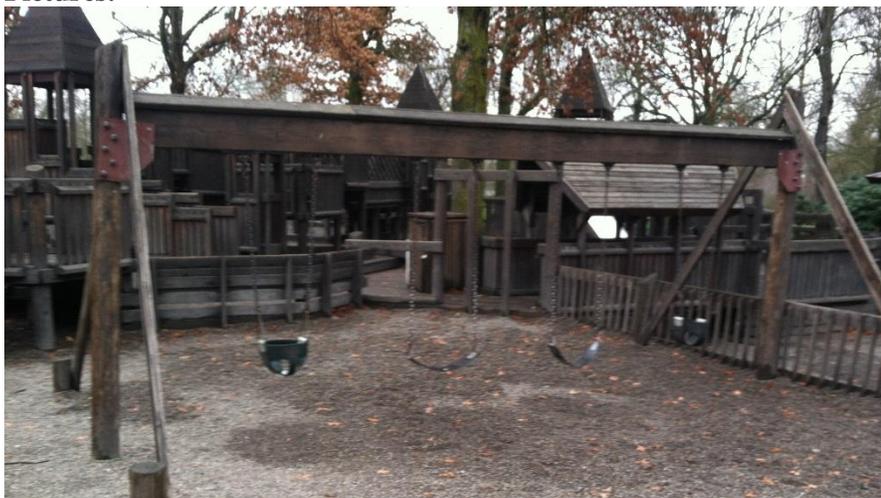
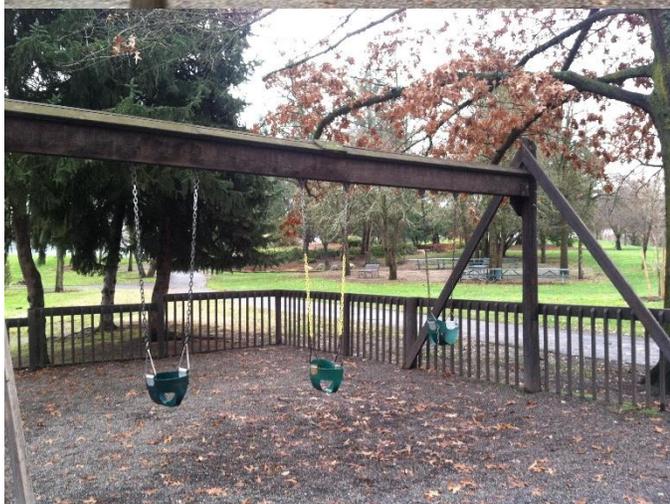
Equipment type/name: Swings

The use zones do not meet current standards, and there should be only 2 swings per bay.

Replace with lower maintenance, manufactured swings.

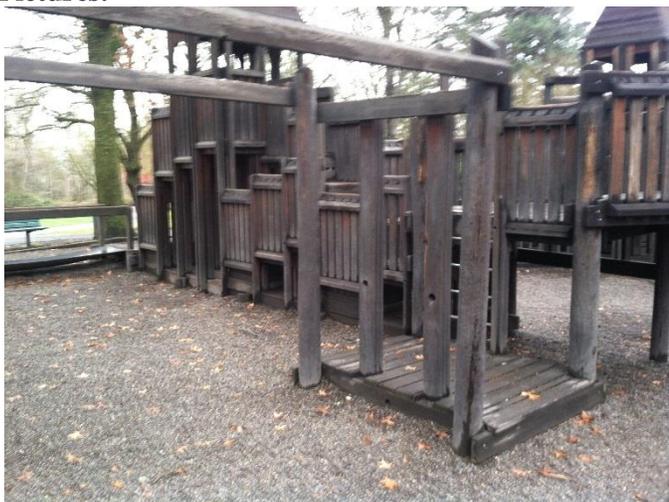
Equipment type/name: Hose and chain climbing equipment

The chain bridge is removed.

Replace with cable version of this equipment

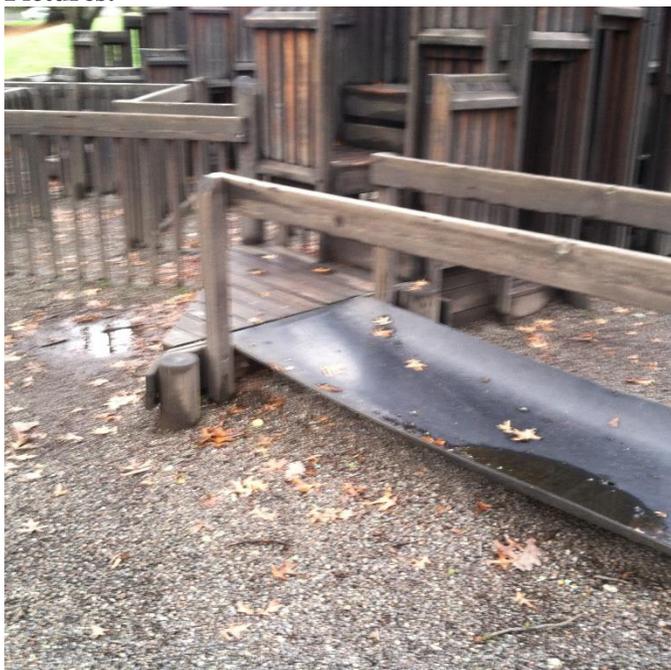
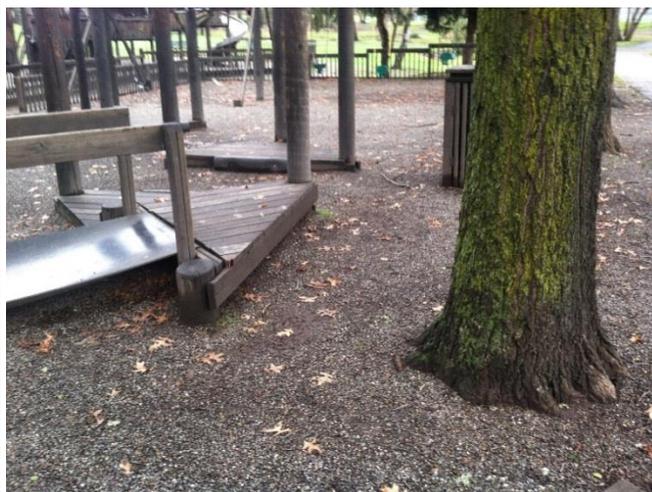
Equipment type/name: Rubber Bridge

Poor Condition

Rebuild using structural plastic lumber as originally designed

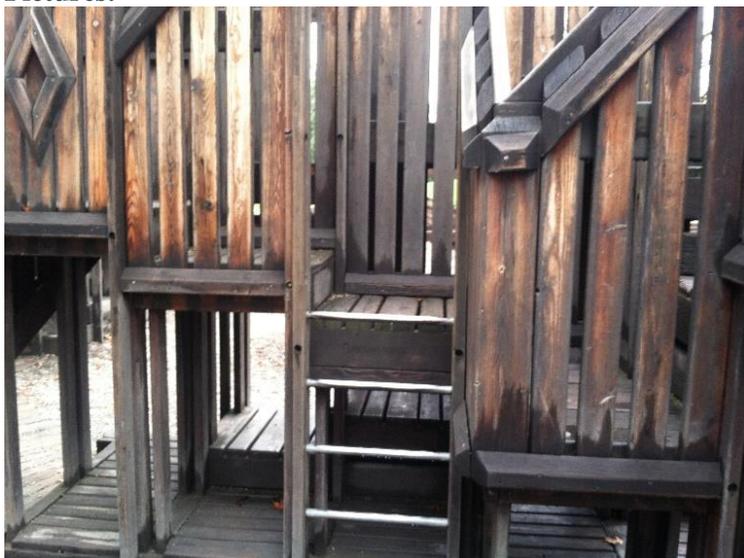
Equipment type/name: Vertical Ladders

Good condition, but does not meet current standards.

Rebuild using structural plastic lumber, to today's guidelines and standards

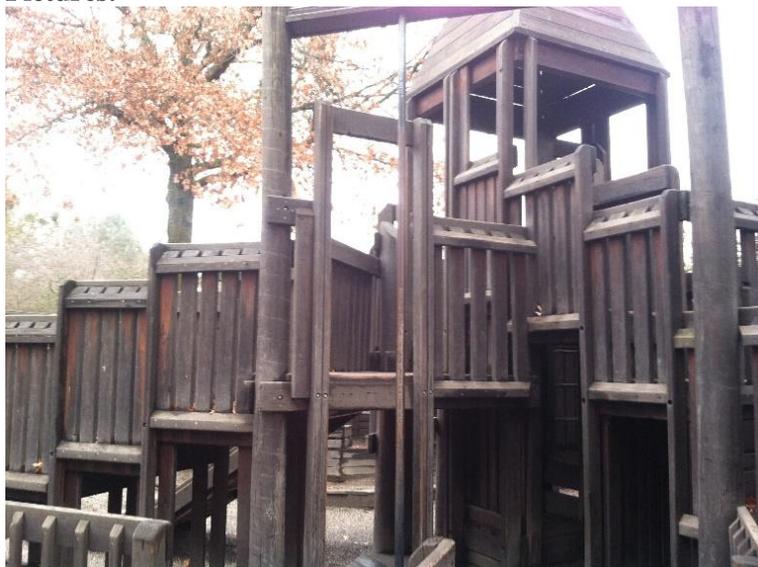
Equipment type/name: Fire Pole

Not to current standards

Rebuild to today's guidelines and standards

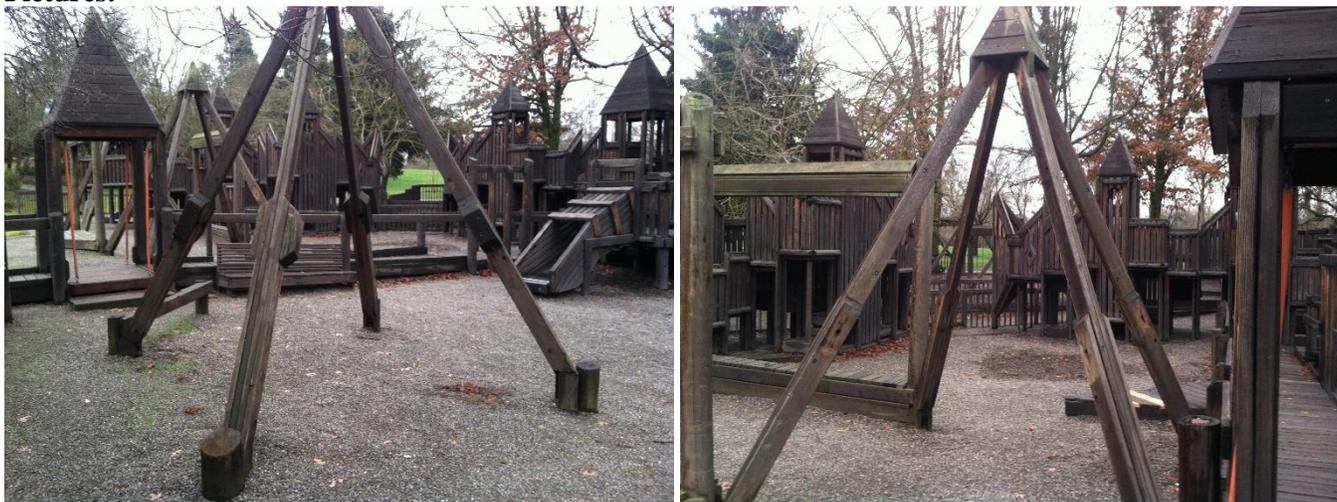
Equipment type/name: Pyramids – Swinging Platform & Bouncing Horse

Equipment has been removed

Replace with modern equipment, possibly redesign this area to include more accessible equipment based on the needs and wants of the community.

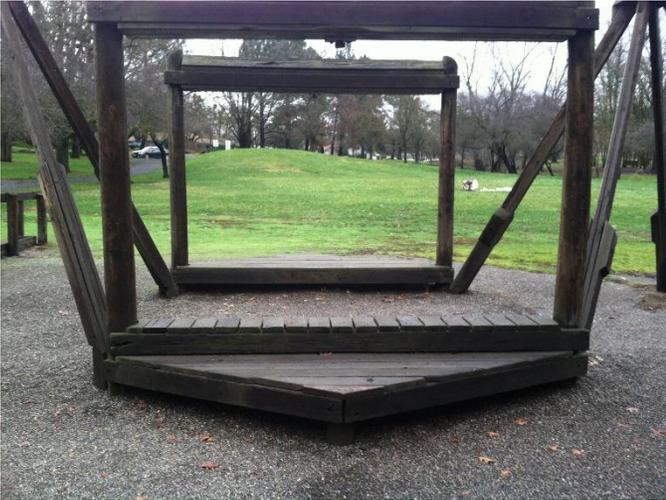
Equipment type/name: Trolley

Trolley has been removed

Replace with the Climbinator

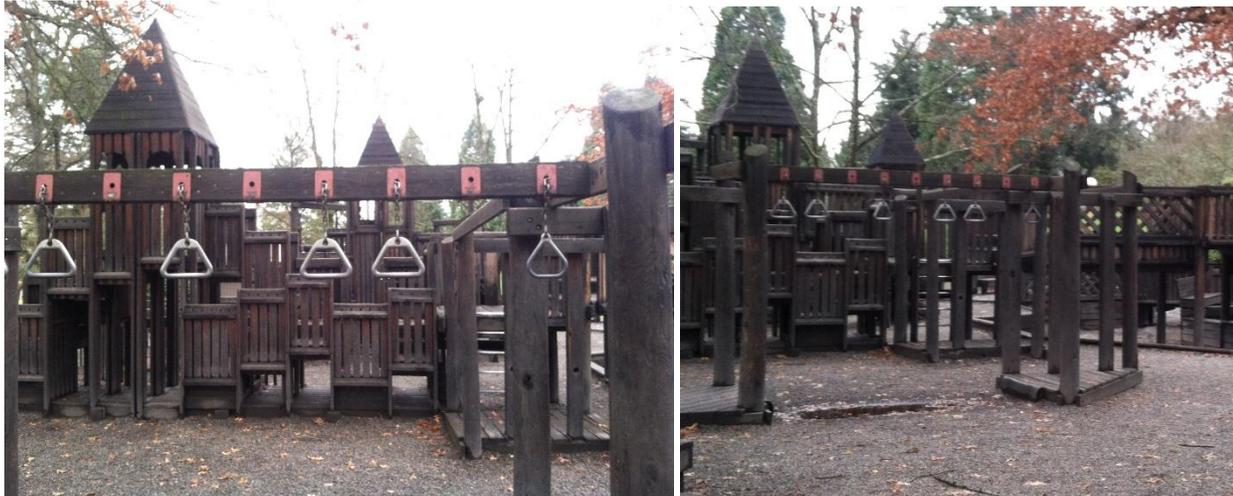
Equipment type/name: Rings (low & high)

Poor condition, missing rings

Replace with lower maintenance manufactured rings

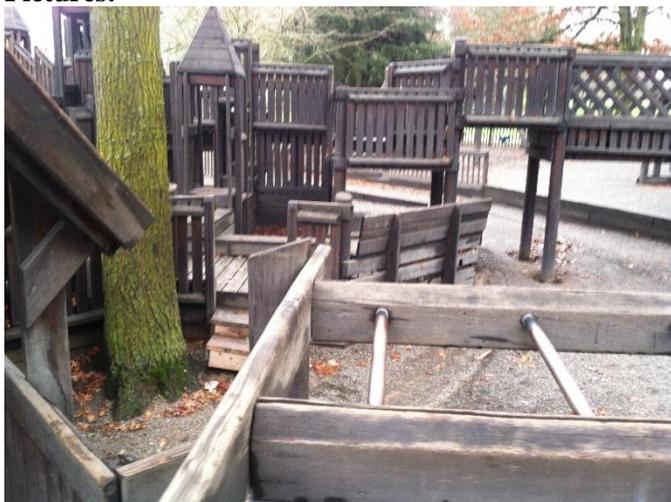
Equipment type/name: Ladders (low & high)

Medium condition

Replace with lower maintenance manufactured monkey bars

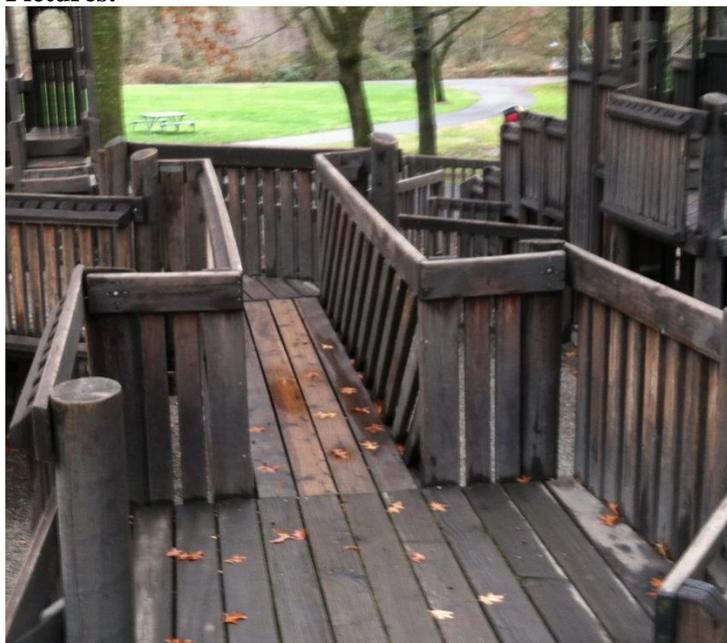
Equipment type/name: Suspension Bridge

This piece has been decked over as a catwalk

Rebuild suspension bridge using structural plastic as originally designed

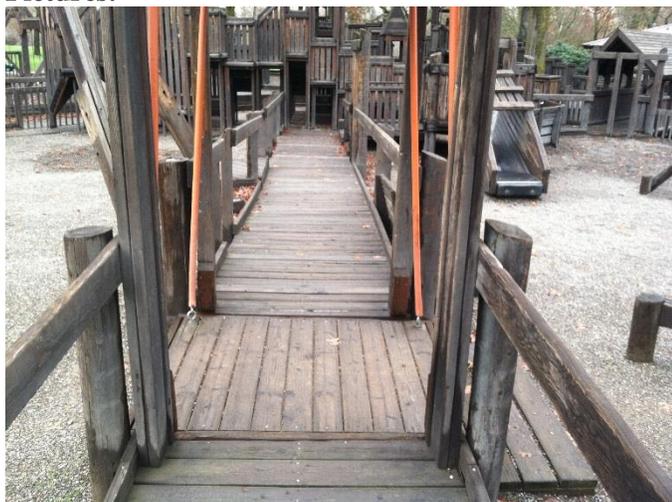
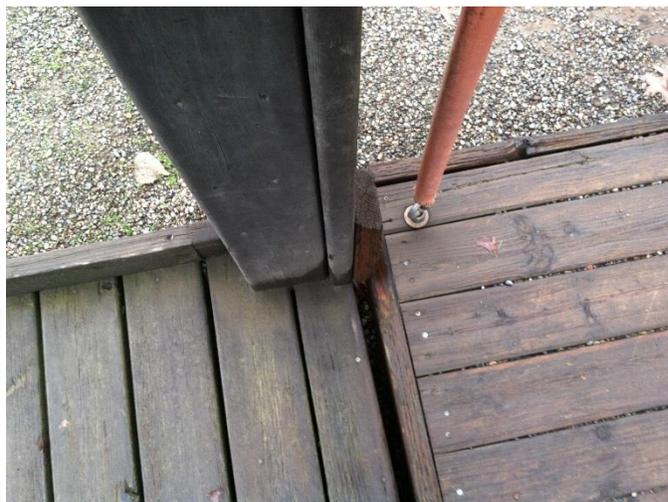
Equipment type/name: Moving Floor

Equipment is dated

Rebuild another moving piece of equipment off the main accessible route
